# Fault finding with an oscilloscope

When a 2006 Opel Vivaro with the 1.9 F9Q engine was towed into the workshop, the customer was expecting a quick “plug-in” to fix the fault. As everyone in the trade knows, this is rarely the case, and this van was no exception. A.D.S recounts the steps needed to get this Opel running again, and how an oscilloscope was key to finding the root cause of the fault.

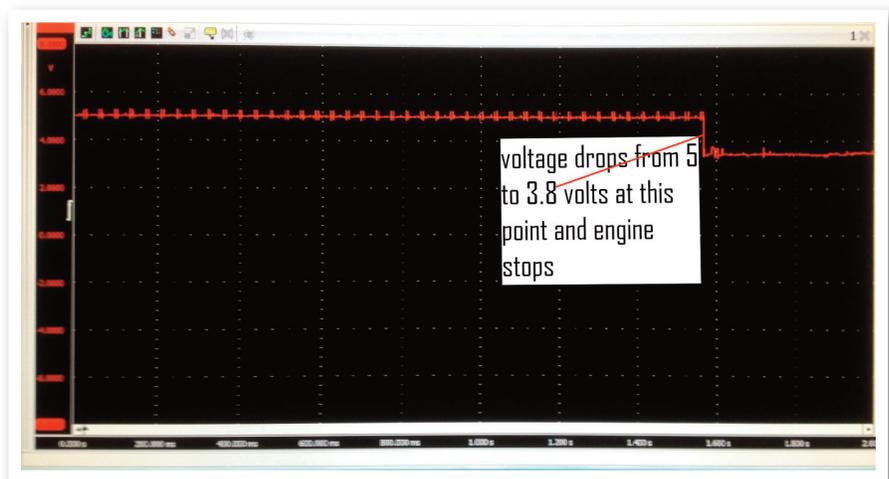
It is almost impossible that all of these sensors could be going faulty at once, and seeing the P1620 fault suggested a voltage supply fault. Fig 1 shows the oscilloscope trace of the 5 volt supply to the fuel rail

Voltage supply to some sensors dropped from 5v to 3.8v whenever the engine stopped

pressure sensor. It captures the moment the engine stops and shows the 5 volt supply being dragged down to 3.8 volts. When tested on the other sensors, for which the faults were present, the same results were found. The next step was to disconnect the fuel rail, air mass, boost pressure and pedal position sensors, in turn with the scope still connected to see if the voltage returned to 5 volts. Even with all of these sensors disconnected, the supply voltage still remained at 3.8 volts.

It was discovered that the same 5 volt supply from the ECU powered the position sensor for the EGR valve. Disconnecting this sensor caused the supply voltage to immediately rise back to 5 volts, and the engine started straight away.

Strangely, no fault code had been logged for the EGR valve, but a short in the EGR valve position sensor was causing the voltage for all these sensors to drop. The voltage drop at the fuel rail pressure sensor was the cause for the engine stopping.

The EGR valve was obviously being affected by heat, as the fault only occurred after the engine was running for a long time. A replacement EGR valve was fitted, an easy fix in the end, but getting to the fault was the hard part. An oscilloscope and OE information proved invaluable in this case, saving a lot of time and trouble replacing the wrong parts in an attempt to fix the problem.
