Investigations on a BMW X5 Can Bus system

This 2008 BMW X5 E70 3.0D came into the workshop with complaints of lots of lights on the dash and “central electronics failure” being displayed on the centre console. Also the dash intermittently shut down completely and reactivated itself within seconds.

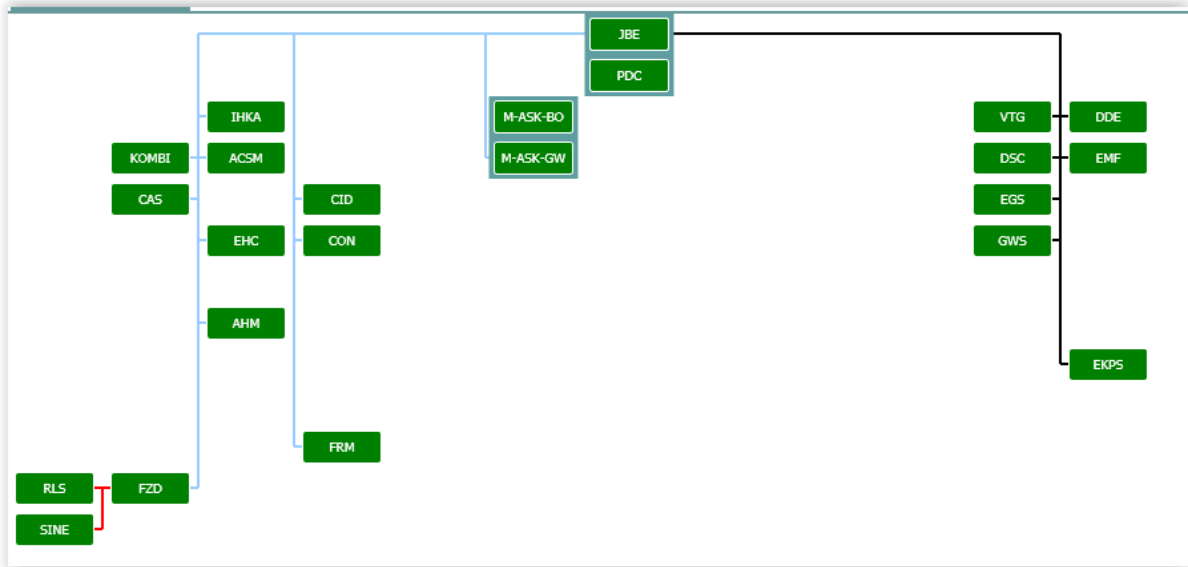
The latter MOST is a fibre optic communication system controlling the media devices on the vehicle. By checking which control units we had no communications with I could easily see that our problem was on the K-Can. I have listed here the control units on this X5's K-Can. Also see figure 2 with the blue lines

- JBE (Junction box Electronics)
- FRM(Football Module)
- CAS (Car Access System)
- CON (I drive controller)
- CID (Central Information Display)
- EHC (Electronic Height Control)
- KOMPI (Instruments Cluster)
- PDC (Park Distance Control)
- FZD (Roof Control Panel)
- MASK (Radio Head Unit)
- IHKA (Air Conditioning Control Unit)

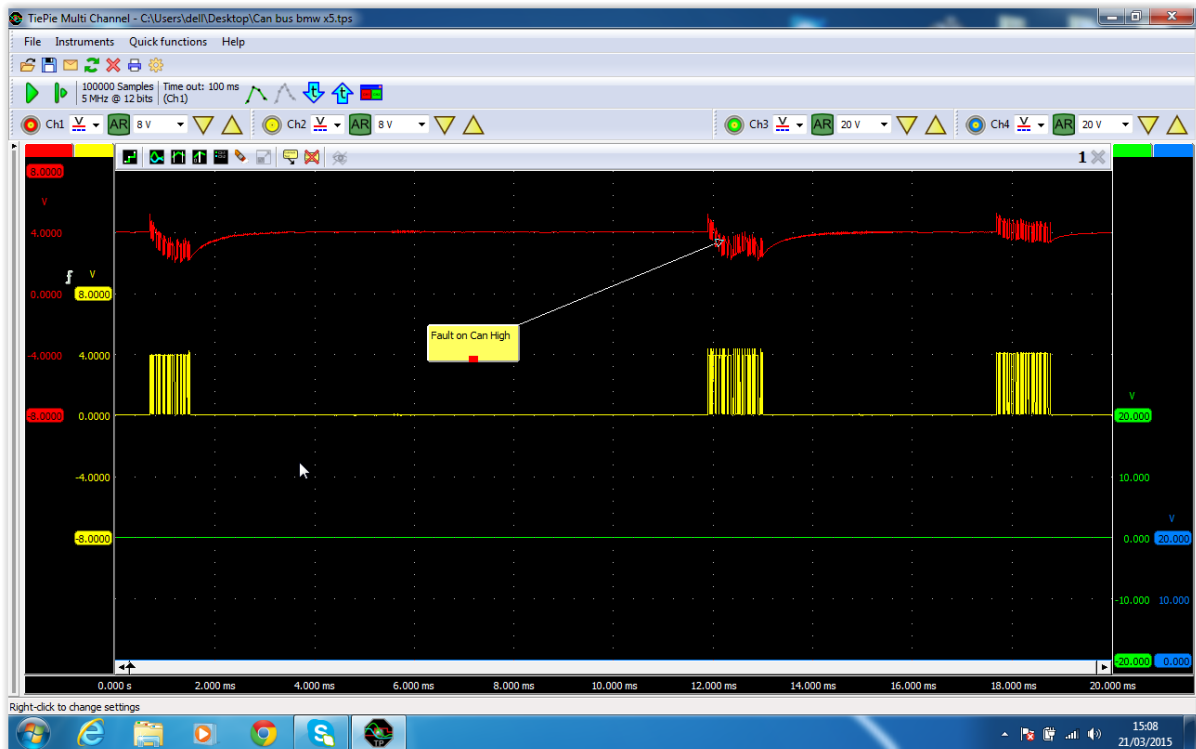
The next step was to get a look at the K-CAN signal on the oscilloscope. The easiest point to connect our scope is at the PDC control unit in the rear right of the boot. As you can see from the picture (Figure1) there was not a complete loss of CAN signal but instead a distorted Can low signal to this control unit.

Unfortunately in this case the signal was still distorted no matter what unit was disconnected which left only a wiring fault as the root cause of the problem. I then started to conduct continuity tests on the can wires between each control unit and a high resistance was found on the Can Low wire going from the CAS Unit (under the dashboard) to the EHC (in the boot) and when the floor mat was lifted there was a dampness on the underneath of the mat and a corroded wire as found in the loom. It turned out that a leaking wiper washer pipe that travels underneath the mat had been the cause of the entire problem. Because the car had been dormant for a year the loom was in a damp environment for an extended period and eventually caused corrosion in the loom.
