When we see a Knock Sensor or Knock Control fault on our diagnostic equipment its not always clear as to whether the fault is coming from a faulty sensor, wiring, control unit or from other engine conditions! Here we take a look at a 2004 1.6 petrol Opel Zafira, which was logging P0325 Knock Sensor fault when put under load or hard acceleration

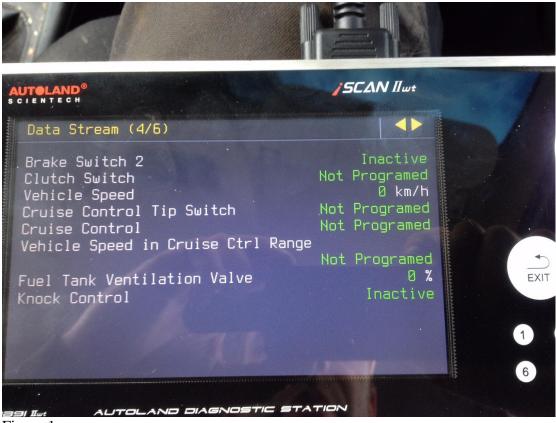
Figure 1

On this car the sensor can be viewed in live data on the diagnostic tool in the form of ACTIVE or NOT ACTIVE as you can see in figure 1 and when the car was driven and the fault happened the reading was always showing NOT ACTIVE. In this case though with an intermittent fault this was not good enough as from this all we knew was that the signal was not reaching the ECU and at this point we had no way of knowing if it was a sensor fault, a wiring fault or a ECU fault. As the sensor had already been replaced on the engine we were doubtful that the new sensor was faulty but to be sure we wanted to test the signal coming from it. The next step was to connect the GMTO oscilloscope to both sensor wires and use the pre-set test built into the database to test the sensor signal see figure 2 The scope was connected to the sensor wires at the ECU plug (instead of connecting to the sensor plug) so as to test not just the sensor but the wires also. When the engine block was given a light tap with a bar we can see from figure 3 the sensor creates the expected voltage on the oscilloscope. This told us that the sensor

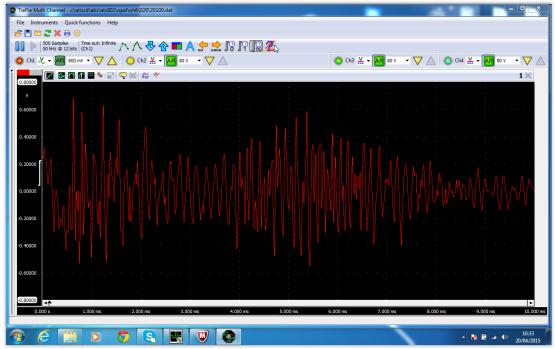
Figure 3

sensor creates the expected voltage on the oscilloscope. This told us that the sensor was functioning normally and the wiring from the sensor to the ECU was ok. Again as it was an intermittent fault I drove the car with the scope still connected to the Knock Sensor wires and using the GMTO,S recorder scope I managed to catch the signal from the sensor at the time of the fault code being logged and as expected there was a signal voltage created by the sensor meaning that the signal was getting to the ECU but the reading in the data stream was still showing NOT ACTIVE This meant the only possible cause was a fault inside the ECU. The ECU is a common

This meant the only possible cause was a fault inside the ECU. The ECU is a common fault on the Opel petrol engines with internal circuit faults, but without the proper tests steps and equipment it would have been impossible to say for definite the ECU was at fault.
