A 2003 Opel Astra 1.7DTI arrived with us last week with a complaint of no power and the customer had been told that the engine ECU was suspected of being faulty as it wasn't switching the boost control solenoid

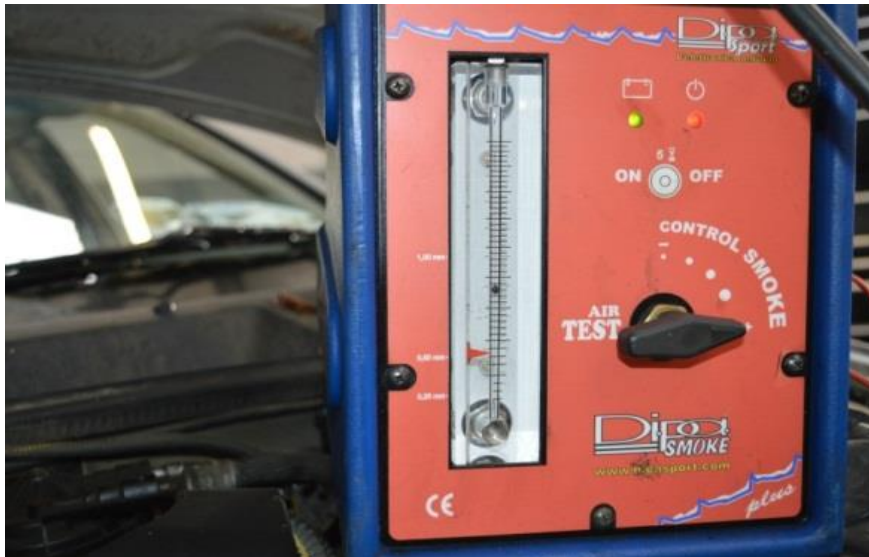
Fig1

The 1<sup>st</sup> thing we normally do in these cases is to check for boost leaks with a smoke machine filling the complete intake system with smoke and then looking for a leak, but there were no leaks visible externally and by viewing the flow meter on the smoke machine see ( fig.1) proved that the EGR valve was also making a good seal, because if the EGR valve was stuck open there would be no visible external leaks in the intake system but the flow meter would be high as it would be escaping out the exhaust.

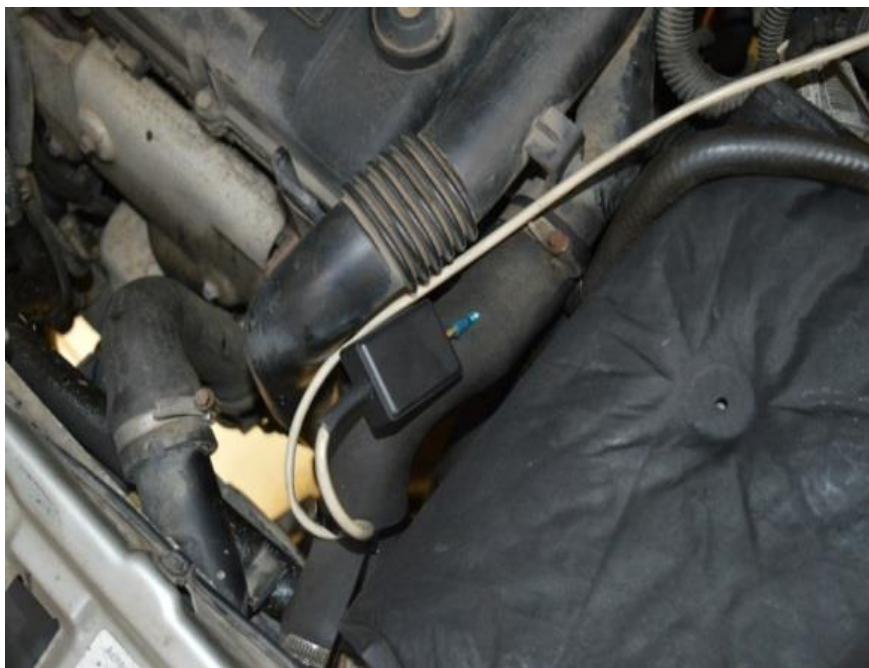
Fig 2

So we decided the next step was to check the actual boost pressure with our Digital turbo pressure tester. As there is nowhere to T into the turbo system on this car this tester is very useful as it works by inserting a small needle into the rubber turbo pipe. The needle is inserted in the direction of air flow (fig 2) through the pipe so that after the needle is removed the turbo pressure closes the hole that the needle made therefore eliminating any risk of causing a leak by the needle. When this test was performed we found that we were getting over 0.82 bar = 0.820 mbar or if you include atmospheric pressure = 1820 mbar (fig 3) actual boost in the system.

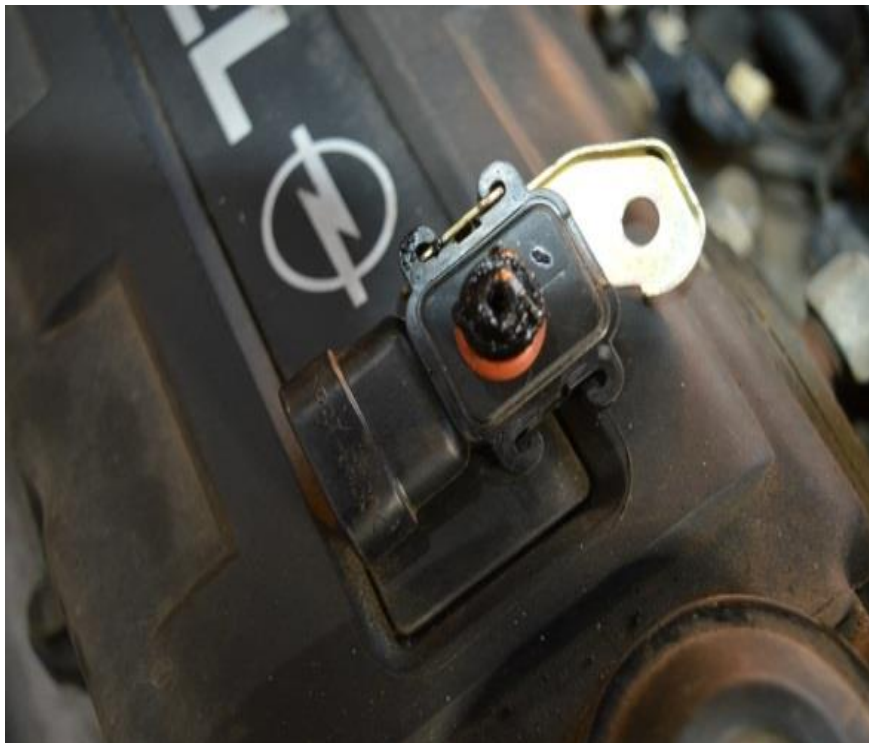
Fig 3

So we knew from this that the system was developing much more boost than the reading that we were getting on our diagnostic tool. The next step was to remove the turbo boost pressure sensor which on inspection (fig 3) was badly blocked with carbon as was the intake manifold. On cleaning the manifold and replacing the boost pressure sensor the full power was restored to the car.
